Name Of Dam: POHICK CREEK DAM SITE NO. 4
Location: FAIRFAX COUNTY
Inventory Number: VA. 05922

PHASE I INSPECTION REPORT

**DEWARD M. MARTIN & ASSOCIATES
WILLIAMSBURG, VIRGINIA
AUGUST, 1979**

POHICK CREEK DAM SITE # 4
FAIRFAX COUNTY, VIRGINIA
INVENTORY NO. VA 05922

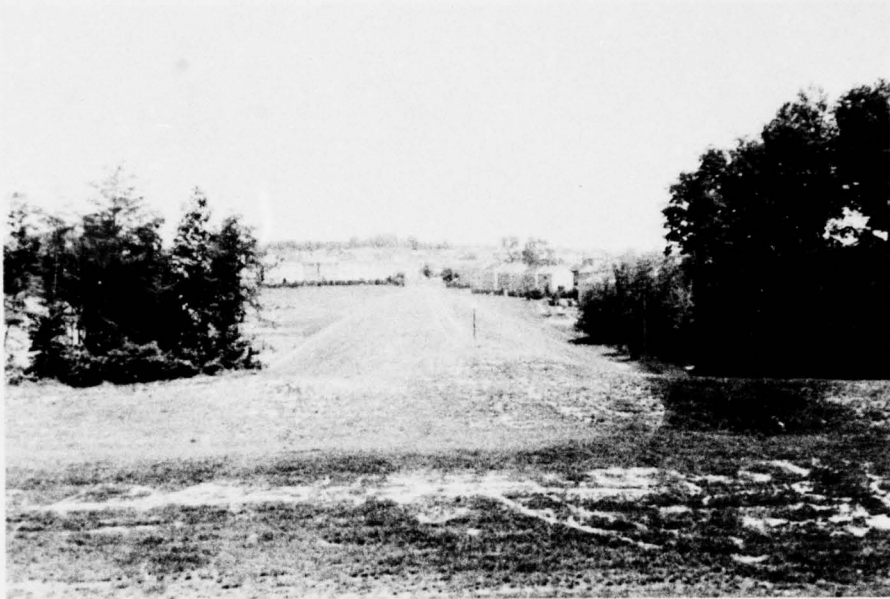
Top of Dam

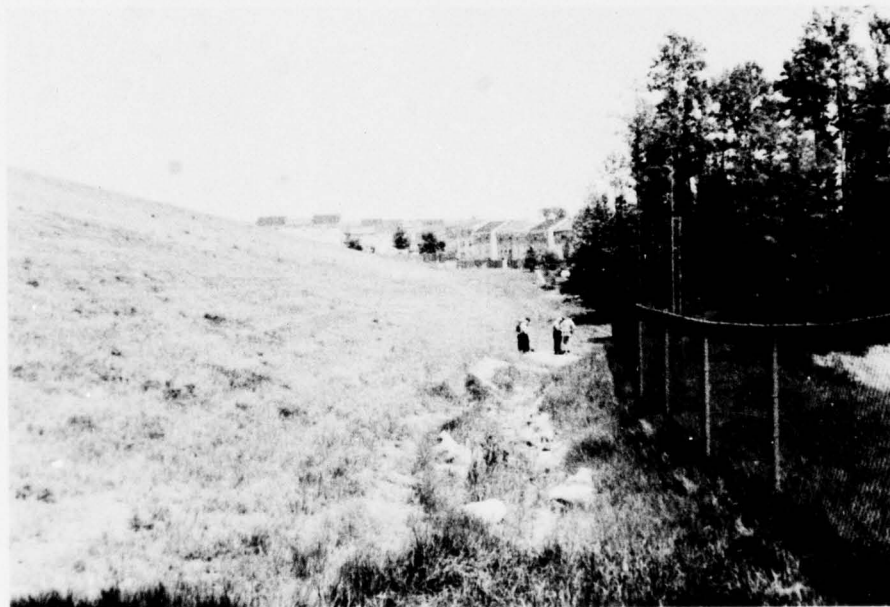
Downstream Face of Dam and Toe Drain

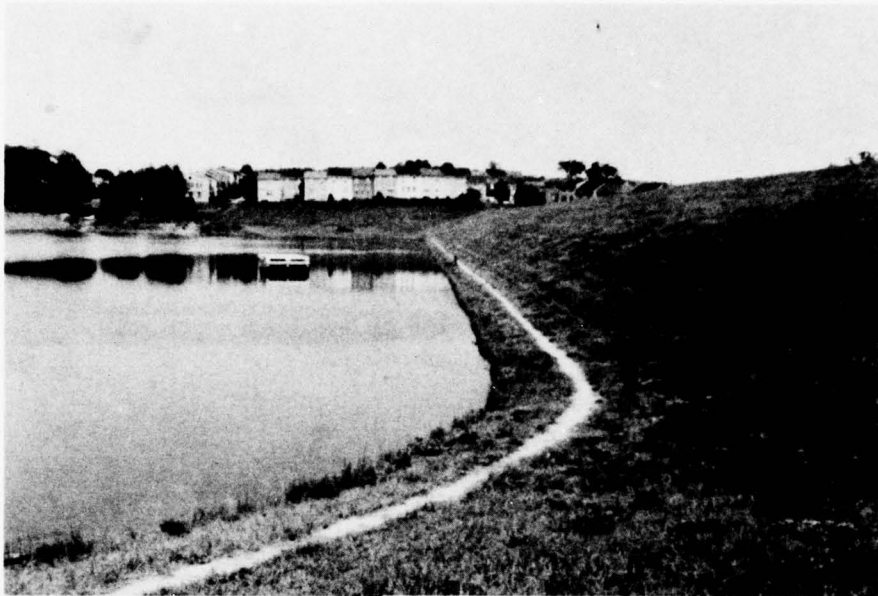
PHOTOGRAPH NO. 1
Upstream Face of Dam and Principal Spillway Intake Structure

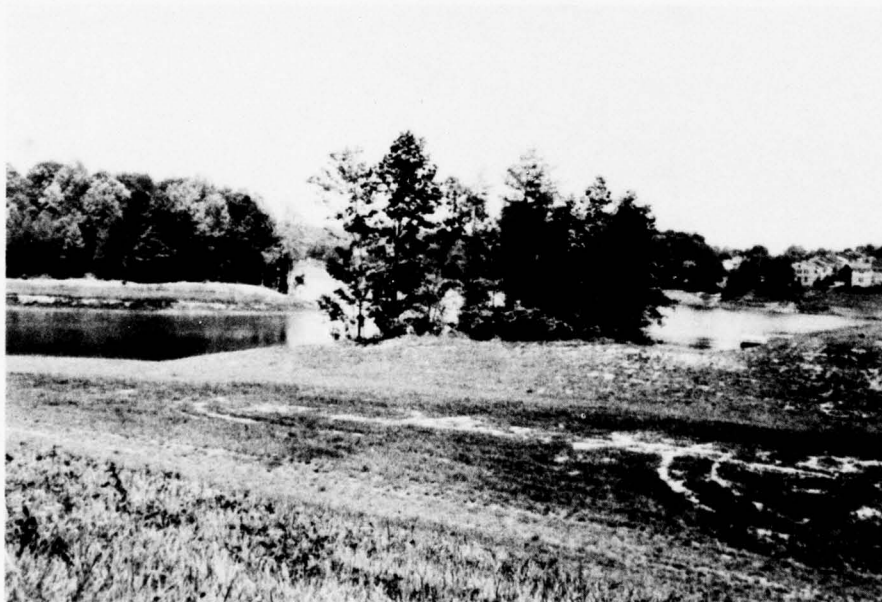
3.1.4 Emergency Spillway: The 100-foot wide vegetated channel is in good condition. The spillway channel is adjacent to a house which is on higher ground and to the right of the spillway. Any undercutting at this point would jeopardize the house.

PHOTOGRAPH NO. 2
Emergency Spillway Channel

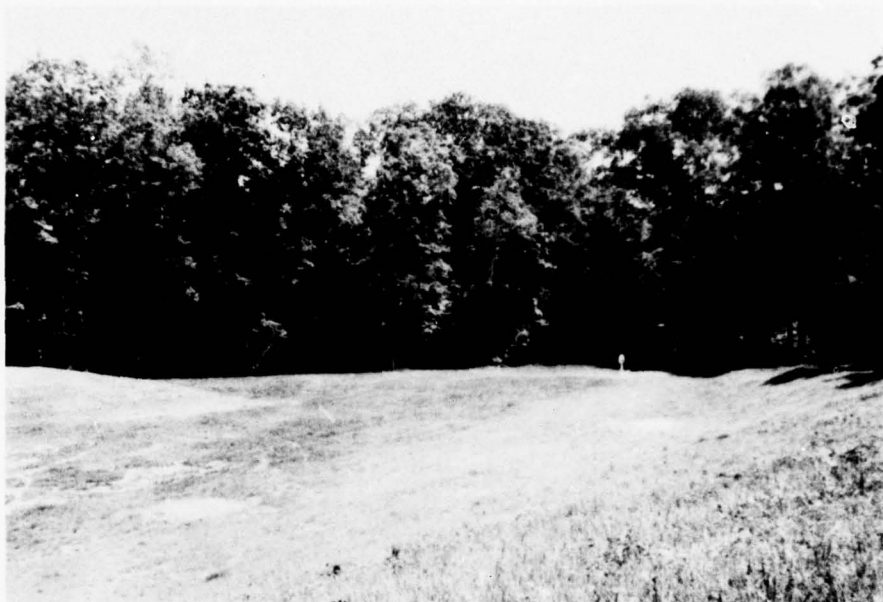
PHOTOGRAPH NO. 3
Emergency Spillway Outlet

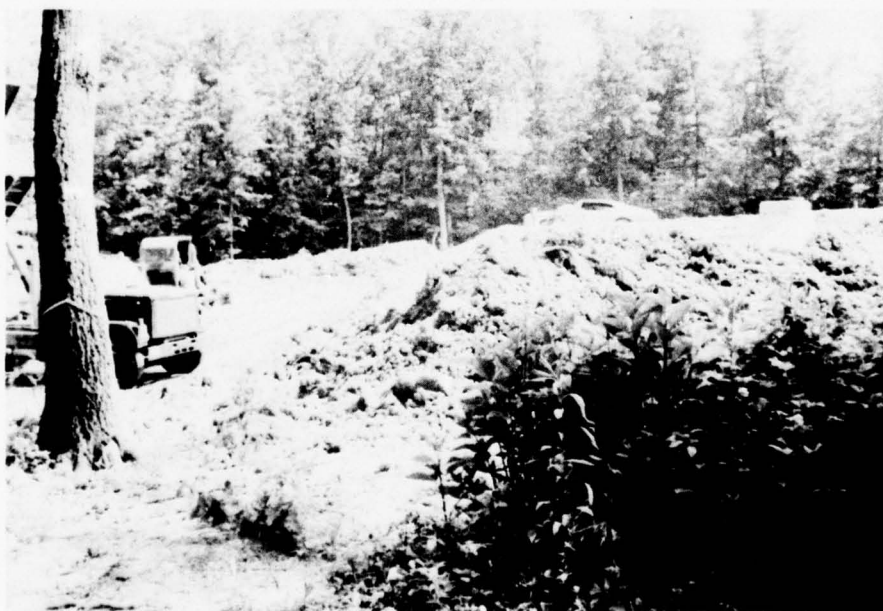
PHOTOGRAPH NO. 4
New Construction Site Adjacent to Emergency Spillway

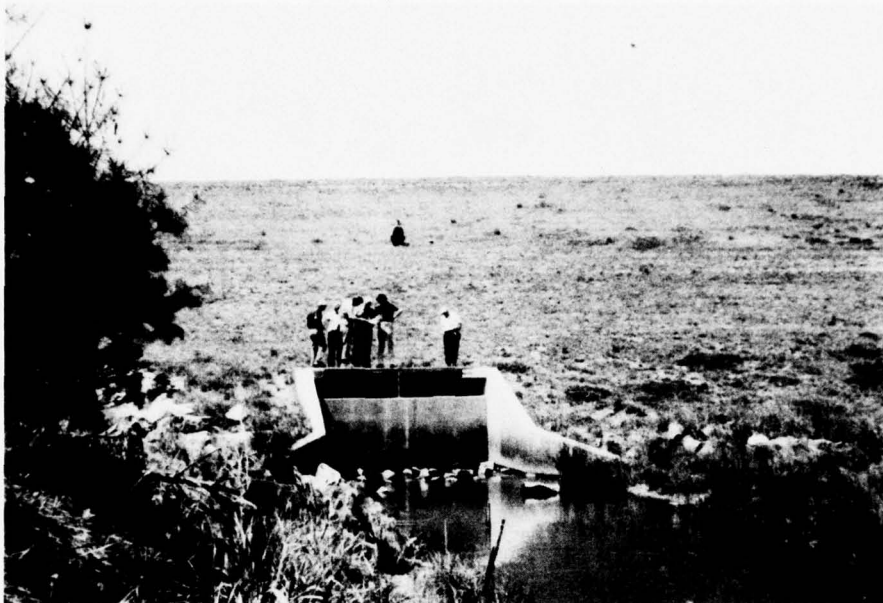
PHOTOGRAPH NO. 5
Principal Spillway Outlet Structure

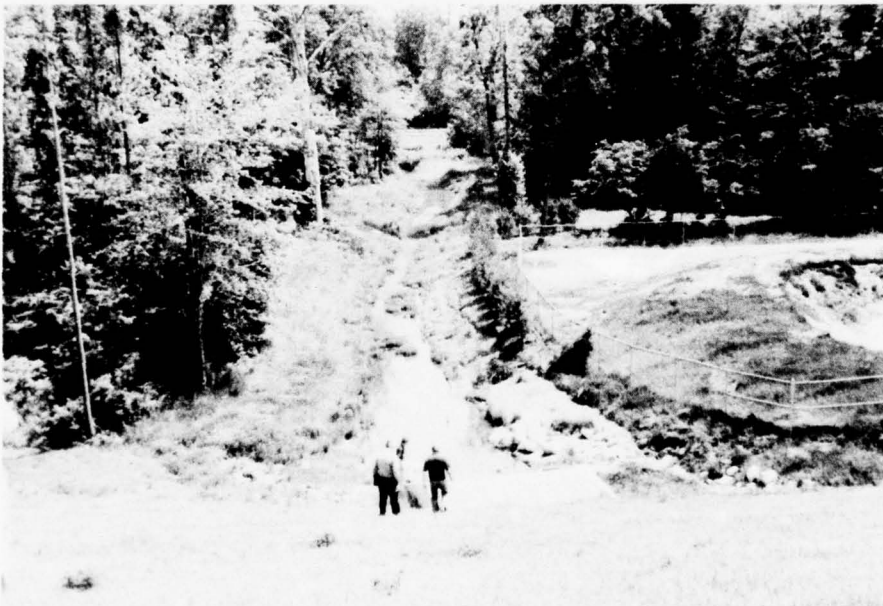
PHOTOGRAPH NO. 6
Downstream
